C O M P R E H E N S I V E   V E H I C L E   C O N D I T I O N

**2023 BMW 4 Series 430i xDrive**

**WBA73AV04PFN89689**

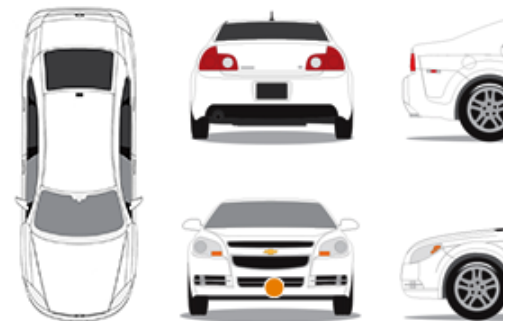
The highlighted points on this vehicle diagram indicate the general areas where our inspection found prior repairs. These issues are not structural in nature and are considered to be purely cosmetic. Please be aware that this diagram may not be identical in appearance to the actual vehicle being inspected.

### Front Bumper Cover

Refinished

Right Fender

Right Front Door

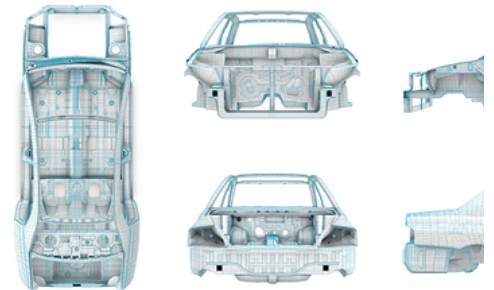
### Engine Bay Underhood (Structural)

| | Meets True360<br>Structural Standards |
|---|---|
| Core Support | ✓ |
| Left Strut Tower / Apron | ✓ |
| Right Strut Tower / Apron | ✓ |
| Cowl Panel / Firewall | ✓ |
| Left Frame Rail | ✓ |
| Right Frame Rail | ✓ |
| Front Cross Member | ✓ |
